Phase 5 of the restoration of Newport Minster and initial work on reordering the interior

A Grants for Places of Worship Project (GP-13-13622)

Evaluation report

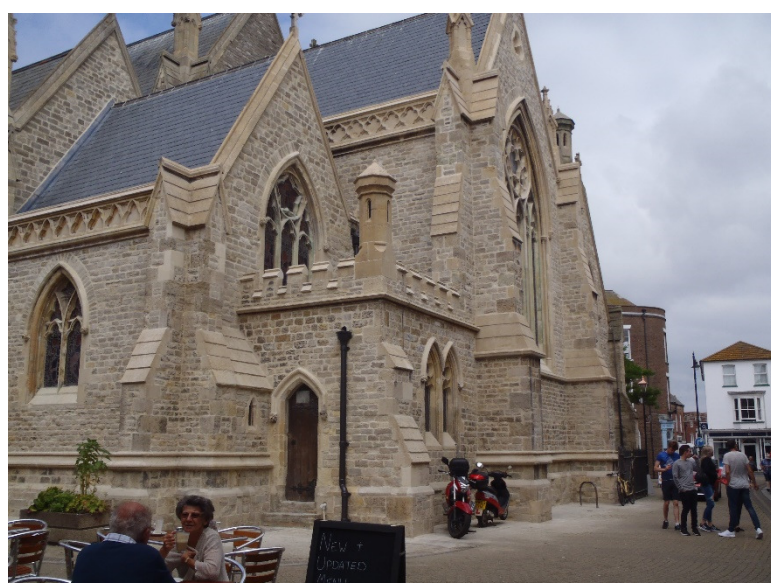
The east end of the church after the work was completed showing the cleaned, restored stonework.

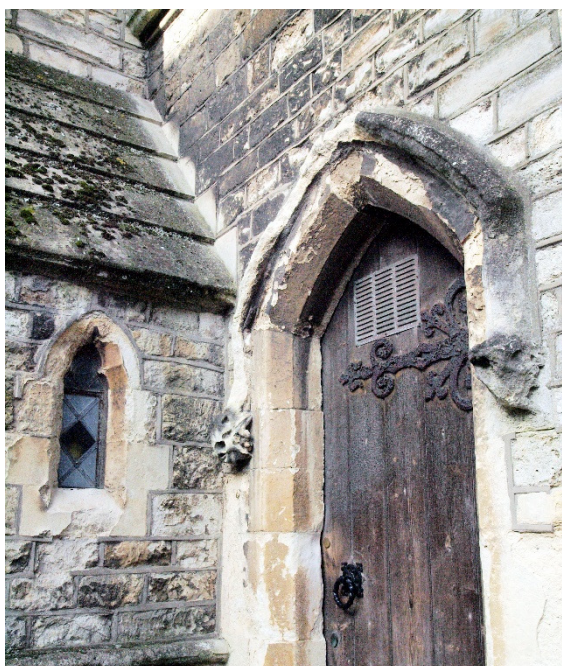
The stonework around the kitchen door before and after the work.

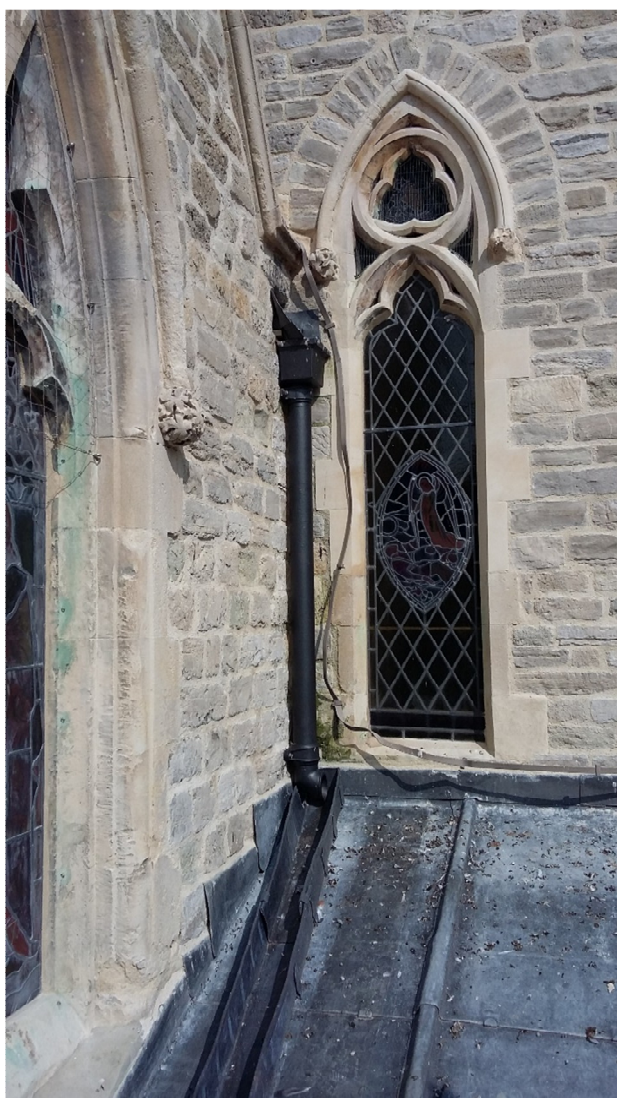
The secret gutter installed at the join of the kitchen roof with the south side of the nave and Horsey Chapel.

During the roofing work the gutters were renewed and a secret gutter installed at the join of the kitchen roof with the south side of the nave and Horsey Chapel.

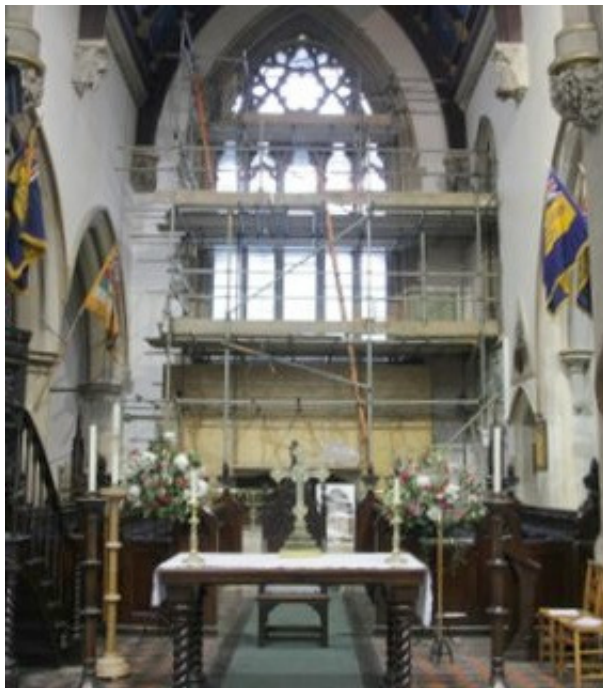
The east Chancel window with all panes removed

Once the scaffolding was in place the large east Chancel window, the main lights of the Horsey Chapel east window and one light of the Masons window were sent to a specialist contractor off-site for major repairs. The rest of the stained glass windows were repaired on-site and new windows were installed in the kitchen and toilet.

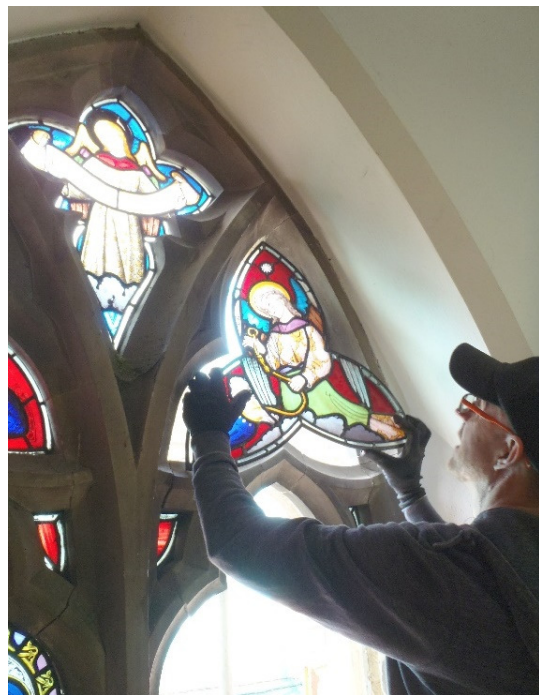
Replacing a repaired light in the Masons' window.

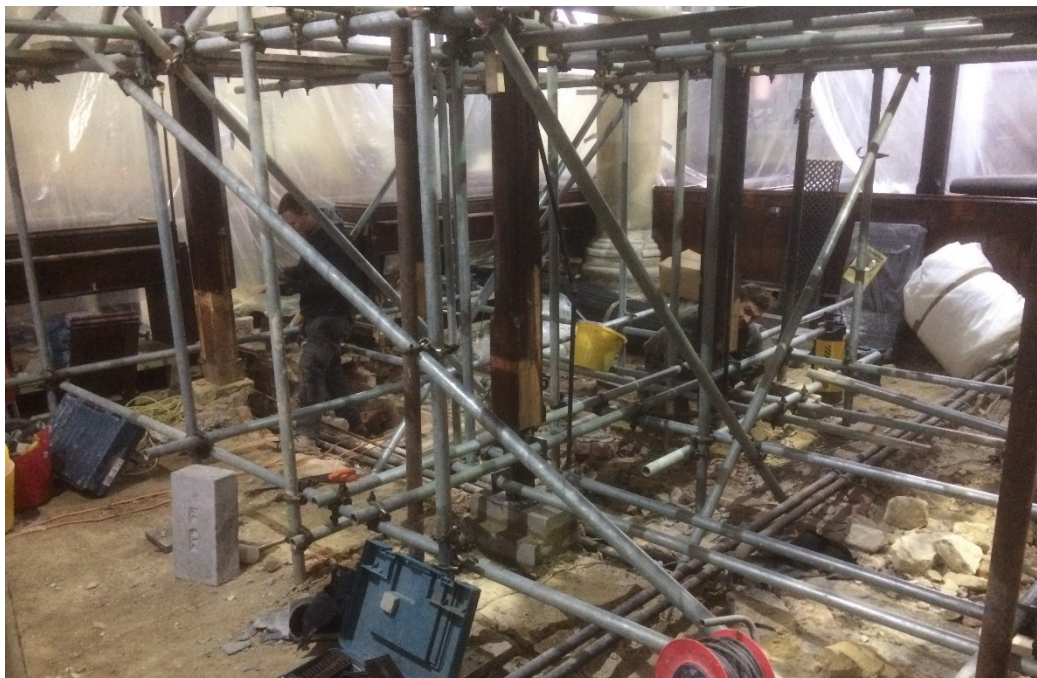
The box pews and wooden pew platform were removed in January and the underlying surface prepared for re-flooring. During this work one of the gallery supports fell out as there was no housing at the top and the stonework it was resting on was badly decayed. Immediately a supporting framework of scaffolding was installed and all six posts provided with good foundation bases. The work on the floor was halted while the posts were made safe.

Additional supporting scaffolding installed under the gallery after one of the posts fell out.

The gallery support posts were resting on badly decayed stone blocks that were only revealed when the floor beneath the gallery was removed. During the work to restore the bases one of the posts dropped out and a supporting framework of scaffolding had to be installed immediately before work could continue. This

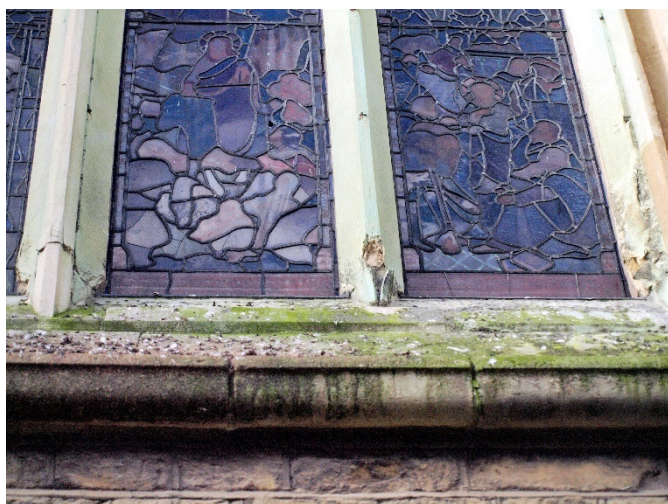
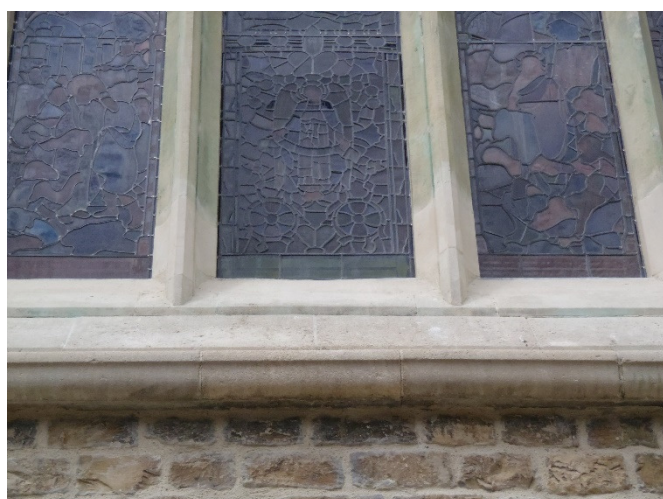
The base of the large east window before and after the work showing the restored and cleaned stonework.

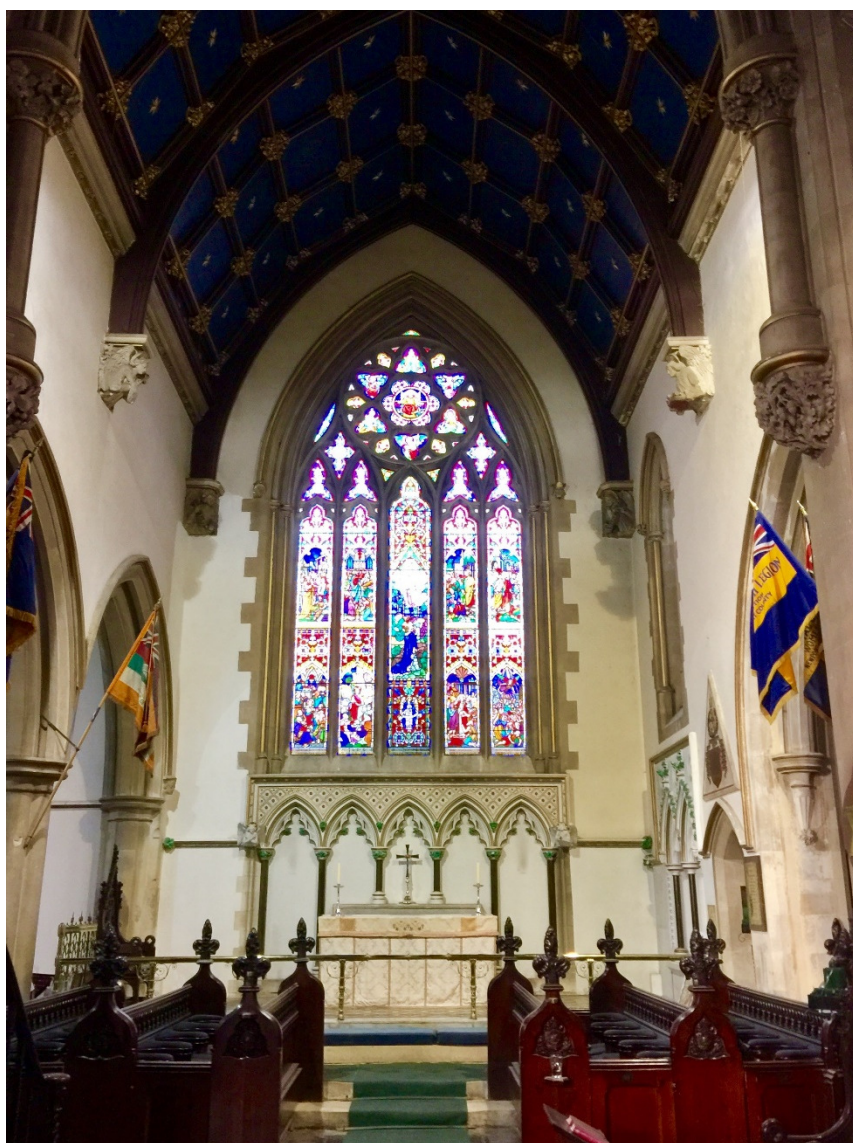
The cleaned and restored east window.

The east Chancel window and Horsey Chapel window (main lights) were scheduled to be taken out and sent to a specialist workshop for repair and cleaning. On inspection of the windows from the scaffolding extra lights from the Horsey Chapel window and the Masons window were also sent for repair.

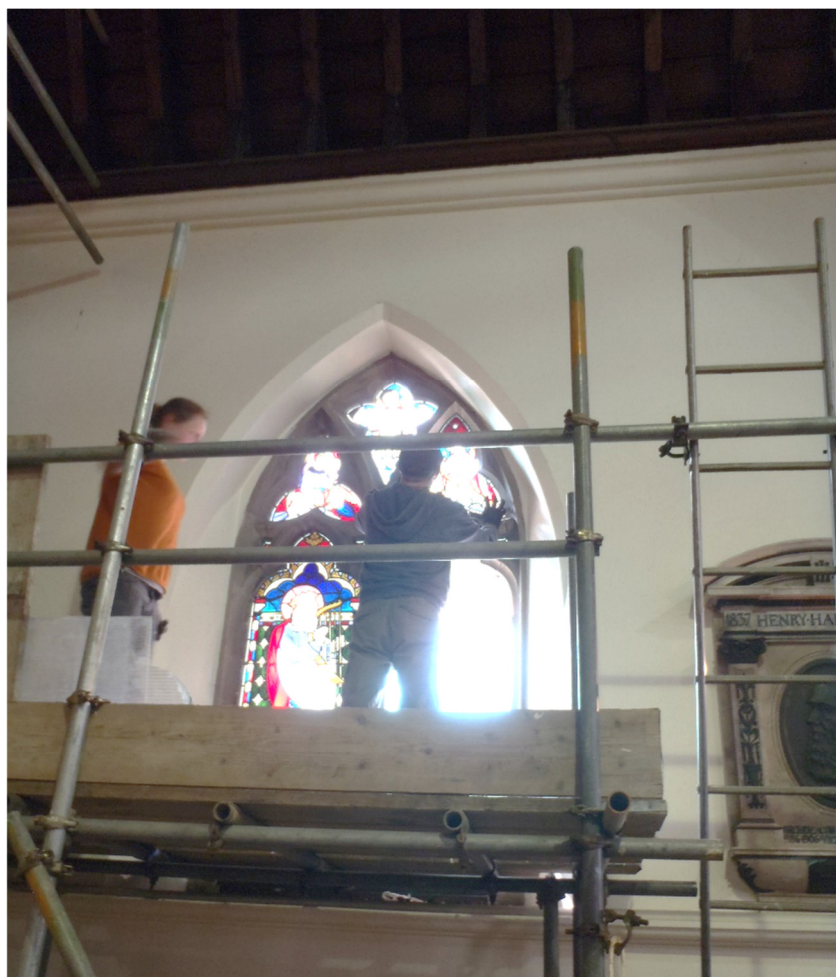
The specialist subcontractor who restored the windows off site supplied a quote with timings that were assumed by the main contractor to include the time to take the windows out and replace them. However, the quote was only for the off-site work. This meant the windows were not ready to be replaced when expected and the scaffolding had to stay up for longer than planned to allow the windows to be replaced. This increased the scaffolding costs and delayed completion of the project.

Replacing lights in the south window of the Horsey chapel later than anticipated due to a misunderstanding on timings between the contractor and specialist glass sub-contractor.
